PART ONE: FEASIBILITY GROUNDING GRID,
PART TWO: RESULTS OF CORROSION AND SOIL ANALYSIS

Sweco Sverige AB was assigned to perform a feasibility study of measurements of the degradation of the earthing grid after more than 40 years in service.

DEGRADATION OF GROUNDING GRID

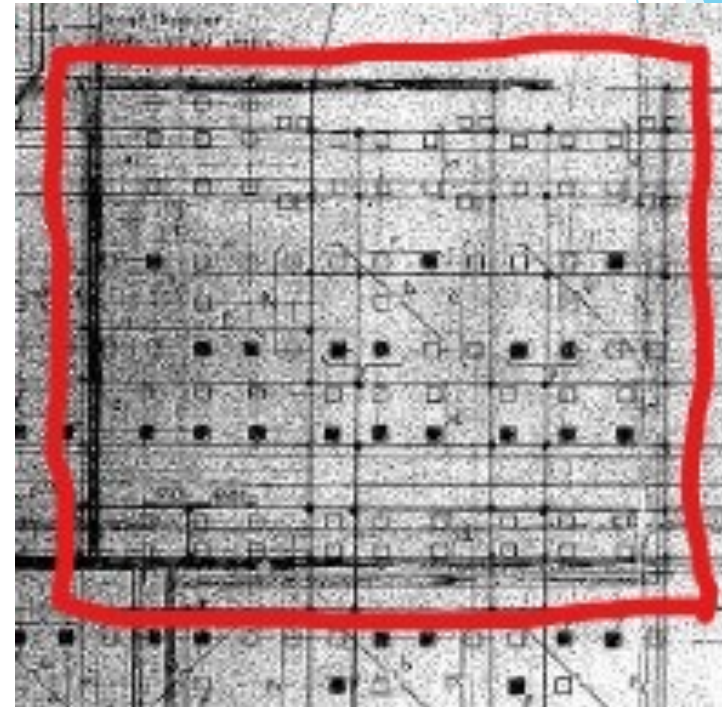
40 year-old documentation. Showing grid and foundations.

At the site of the switchgear there is a grid of copper 120 mm^2 in the ground with a square distance of about $5 \times 5 \text{ m}$ to $10 \times 15 \text{ m}$ depending on the location. Within these squares there are smaller squares of copper 35 mm^2 .

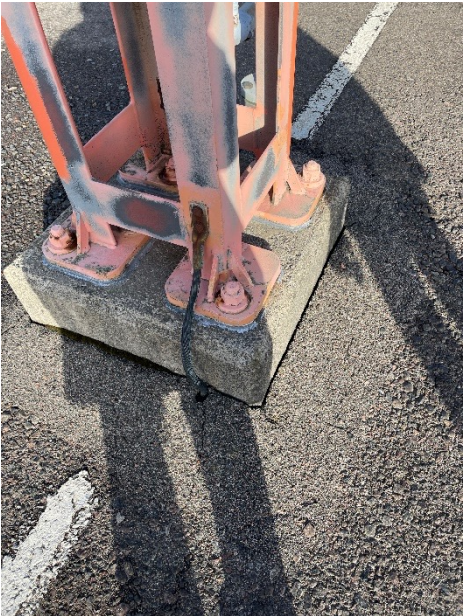
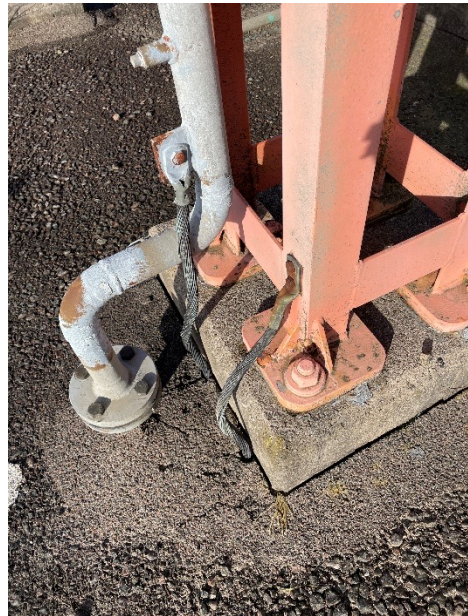
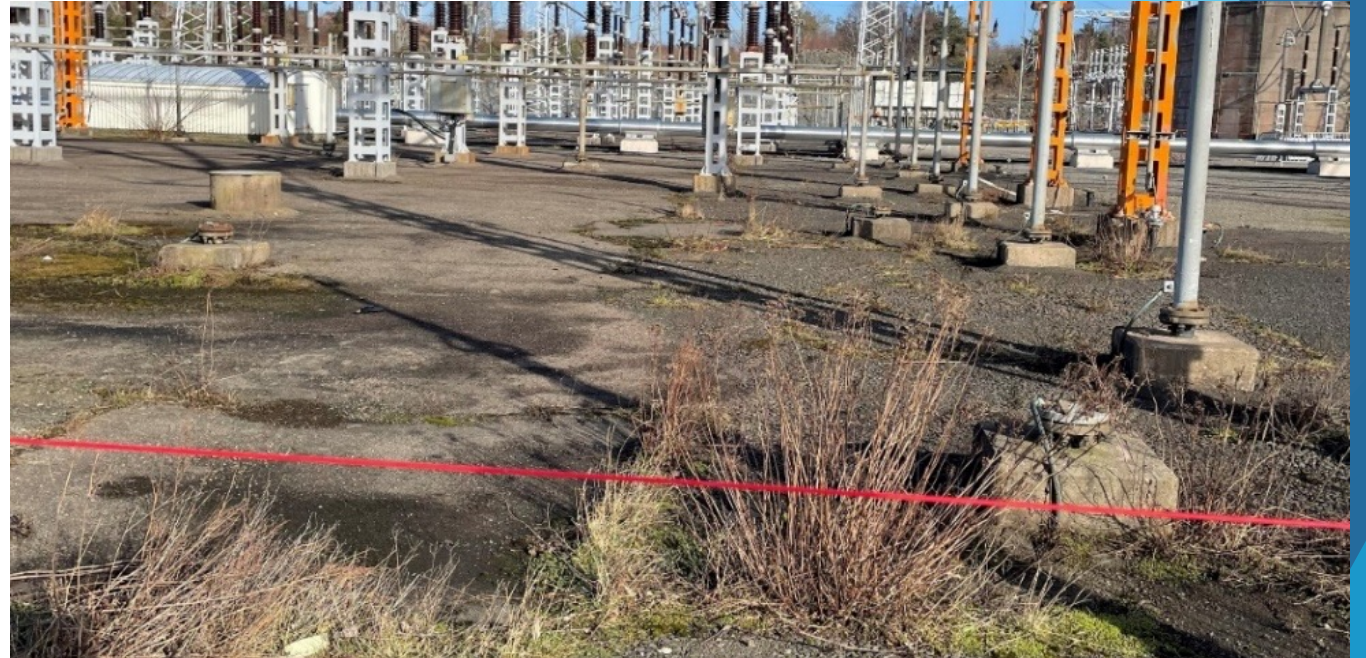
The site is covered by asphalt. In other places gravel is more common.

There is a special process of cleaning the isolators of the site by using large amount of fresh water.

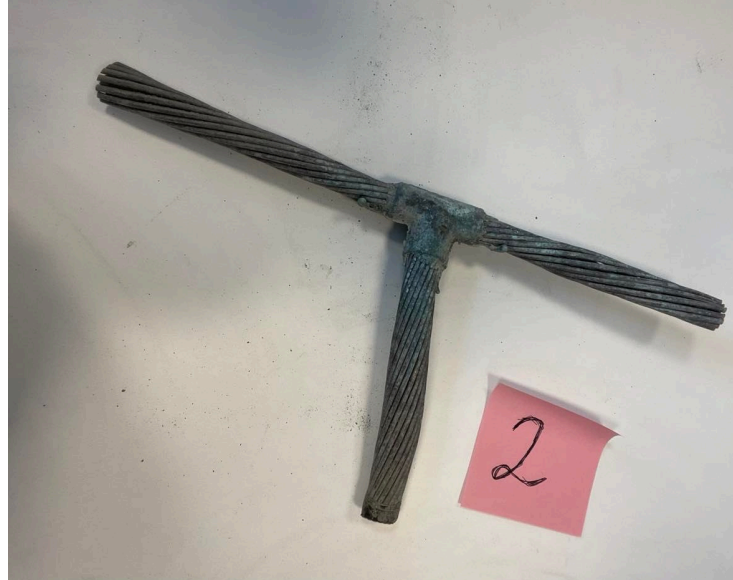
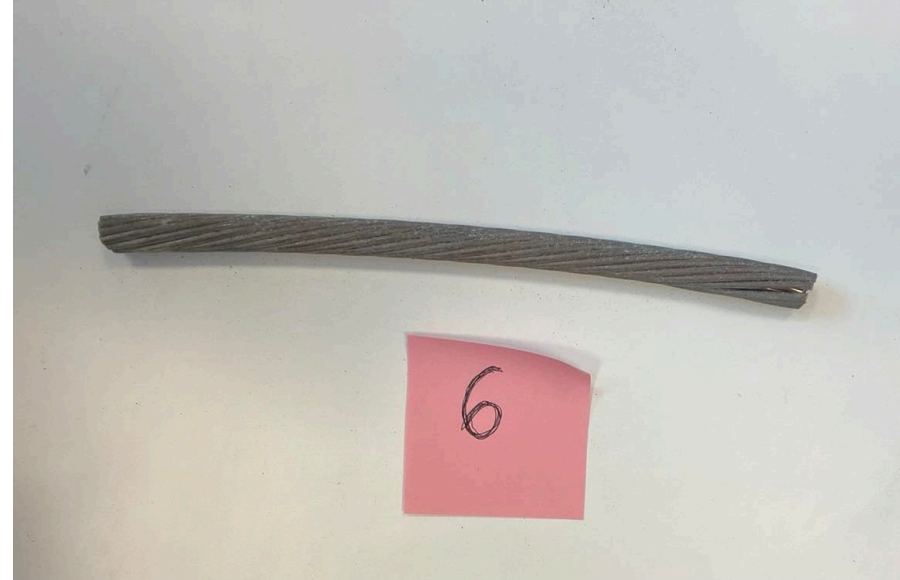
Parts of earthing grid. Send to RISE for corrosion analysis

Soil samples. Send to a laboratory for analysis (Eurofins Sweden AB)
